# **SURVEY OF TREES and WOODLAND**

# **THE CLYDE GATEWAY ACCESS PROJECT**

**Prepared for:** **Glasgow & Clyde Valley Green Network Partnership**

2<sup>nd</sup> October 2008

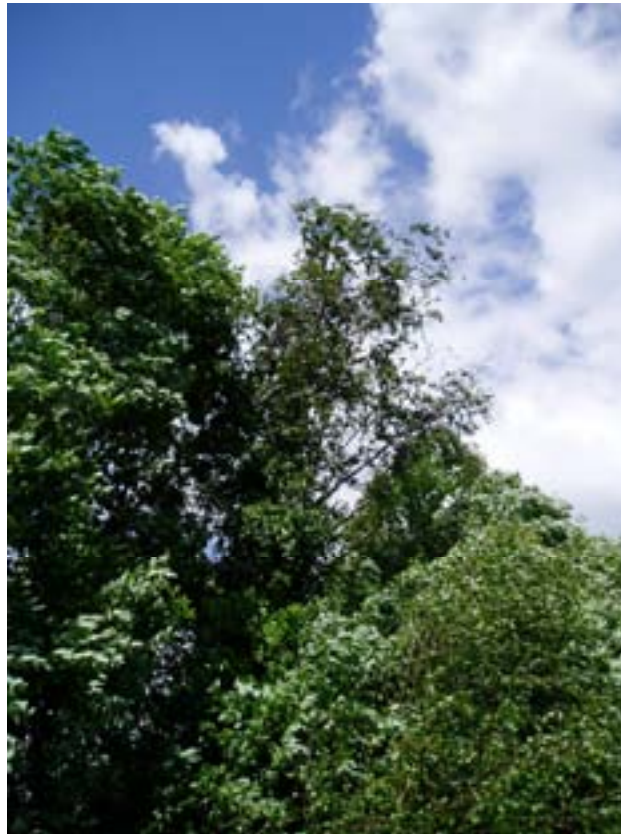
**Figure 1:** (Compartment 1) crown die-back in birch no. 563 A.

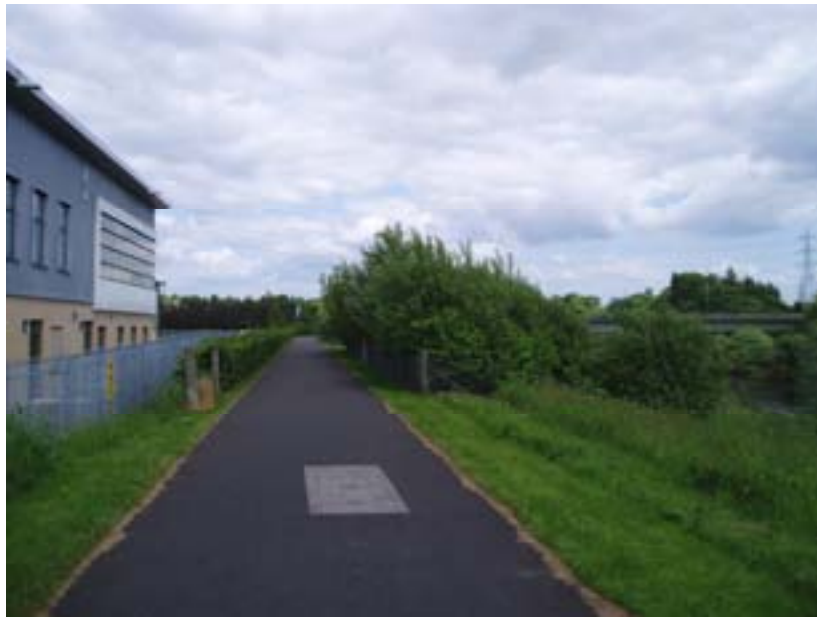
**Figure 2:** Compartment 2a from the west, showing typical enclosure of new planting, now encroaching onto path.

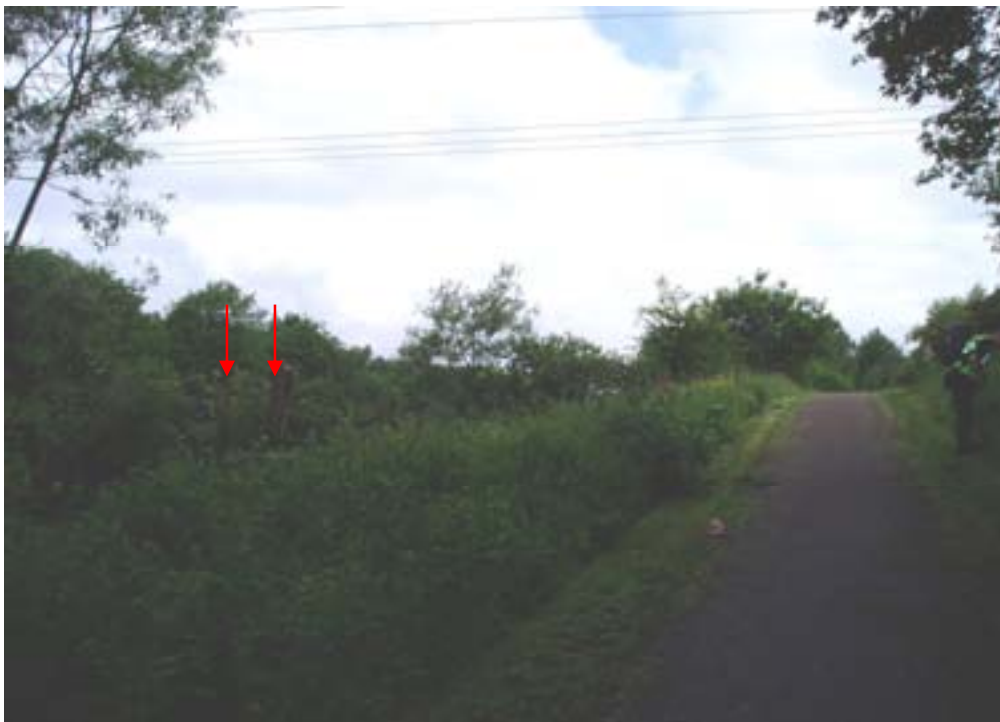
**Figure 6:** Compartment 4a from the southern end (arrows show 'topped' trees beneath overhead lines).

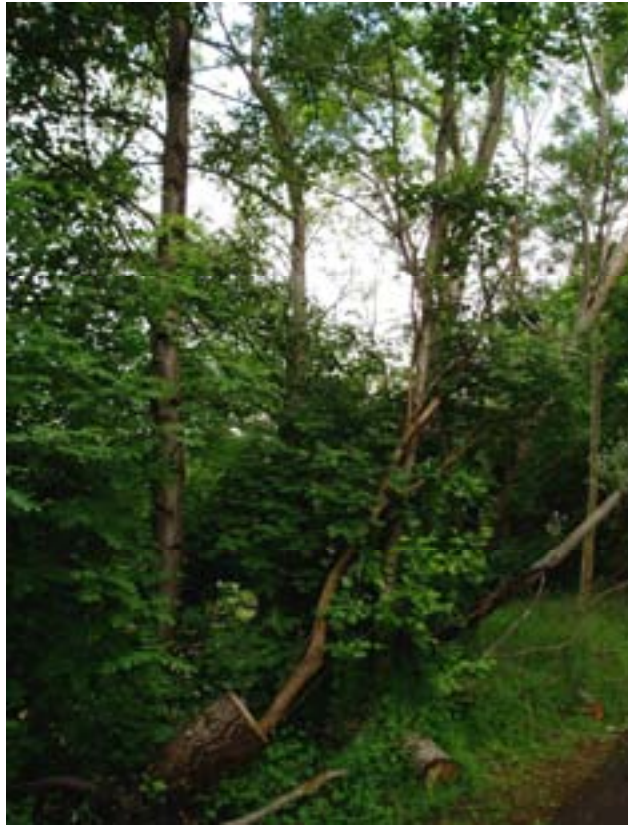
**Figure 7:** Compartment 4b from south-east, showing early-mature willow / poplar, dense natural regeneration and fallen stem.

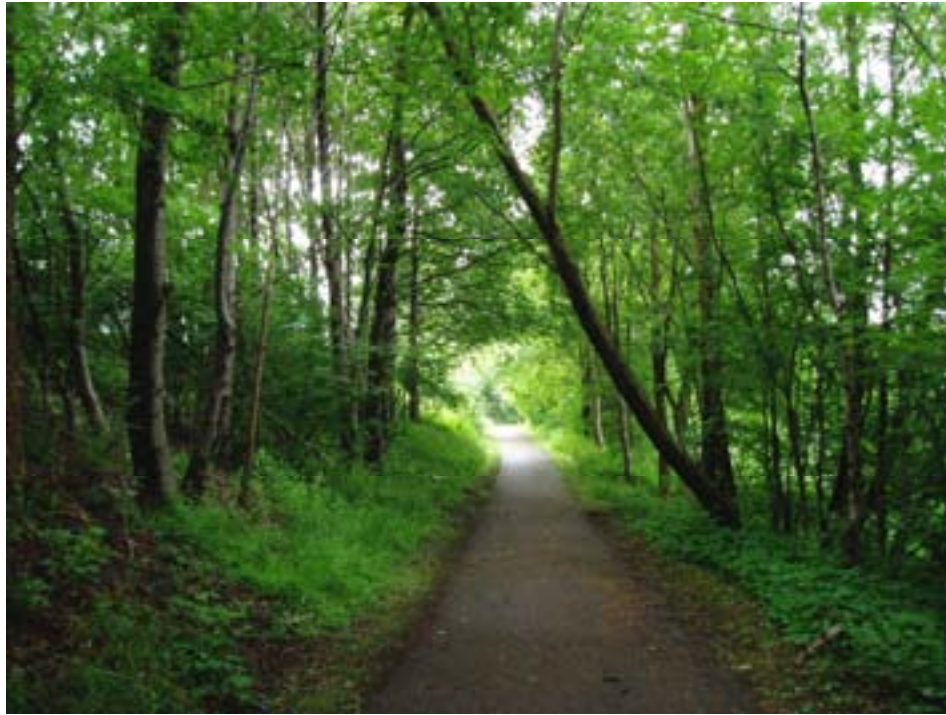
**Figure 9:** Compartment 4d from the north, showing poplar no. 578 leaning heavily over path.

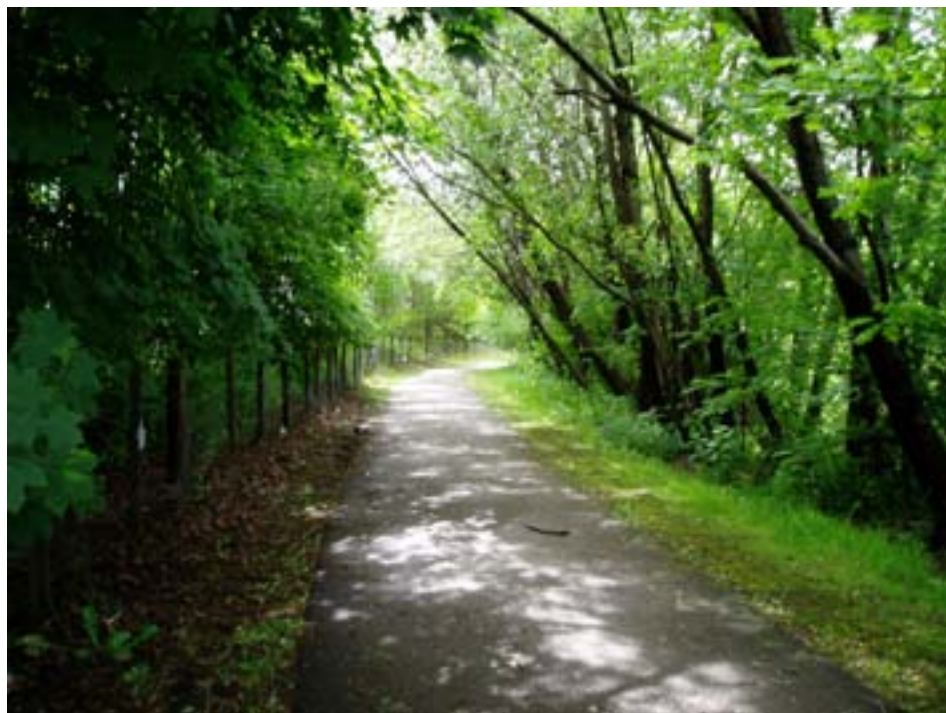
**Figure 10:** Compartment 4f, showing tall, leaning trees (right of picture) overhanging path and young trees in Compartment 4e.

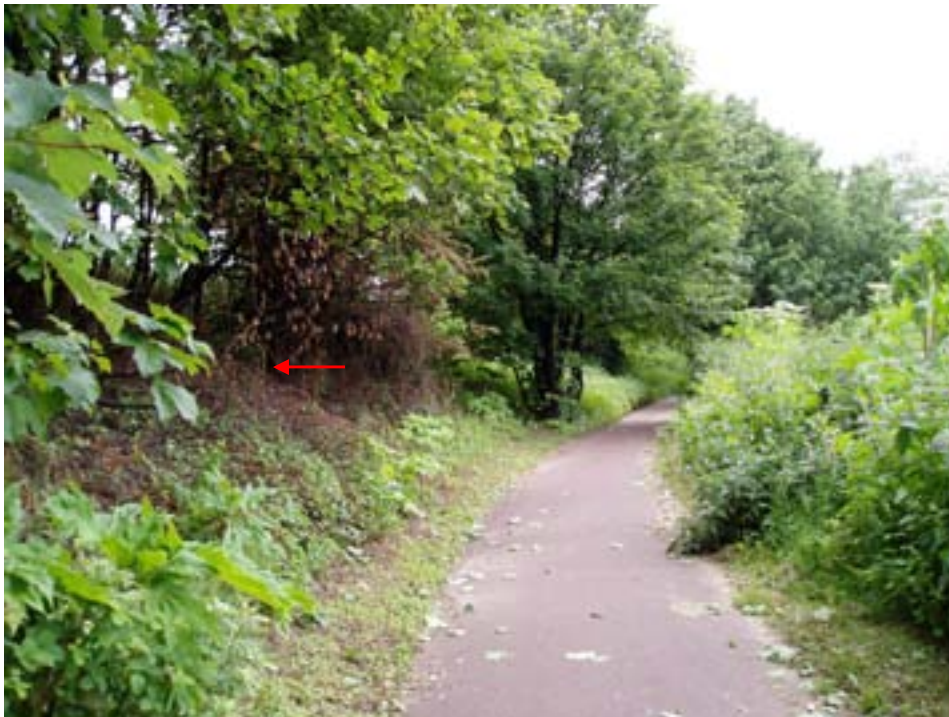
- 3.8.6 Fire-damage to main stems and scaffolds in the lower crown: there is ample evidence of recent fire-setting on the north side of the river, with areas of burnt and blackened trees and undergrowth in places. The prevalence of decaying wounds on one side of a tree only or on a group of trees, where the wounds are all oriented towards a central point, strongly suggests that fire-setting close to standing trees has been a historic problem also. The resulting decay to main stems and large scaffolds means that a significant number of affected trees now require felling.

**Figure 14:** Compartment 6a from the south-west, showing recent fire-damage (arrowed) and vegetation obscuring sight-line around corner.

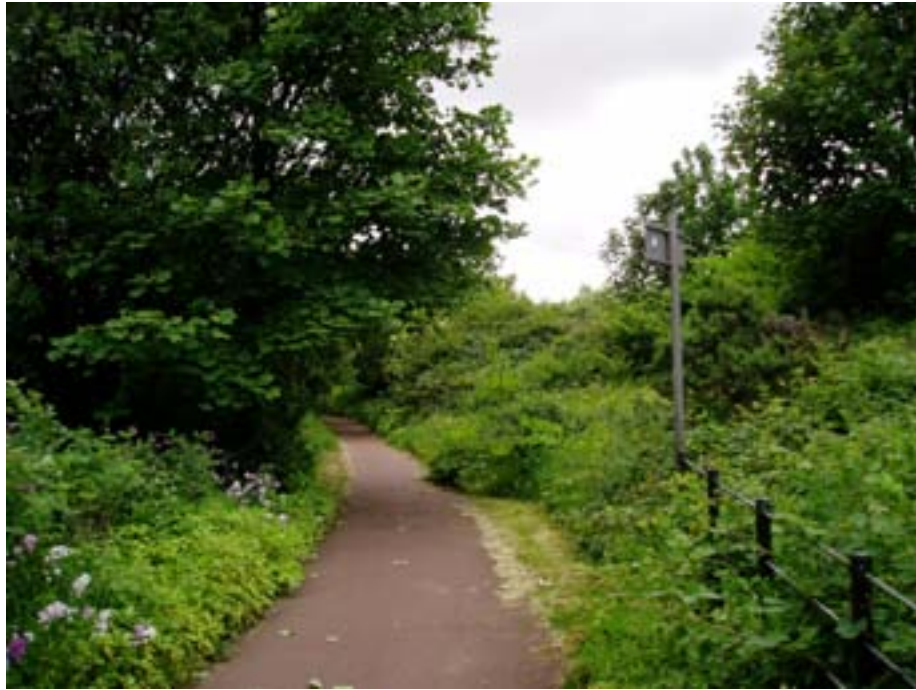
**Figure 15:** Compartment 6b from northern end, showing dense vegetation up to edge of path and overhanging branches.

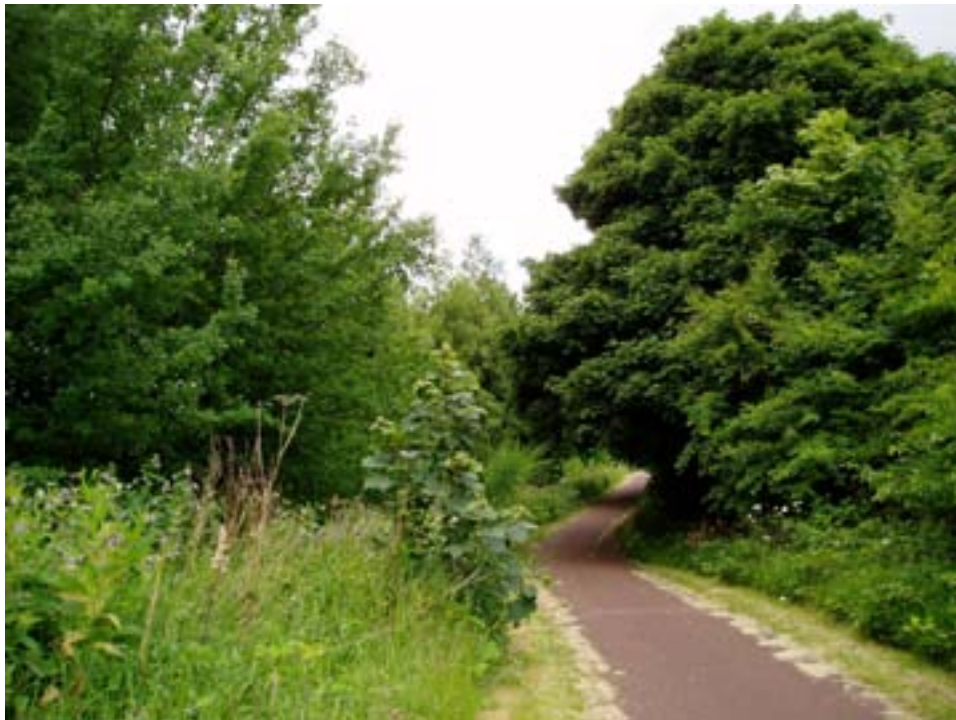
**Figure 18:** Compartment 6e from the south-eastern end, showing early-mature sycamore on the upper side of the path with low branches over the path.

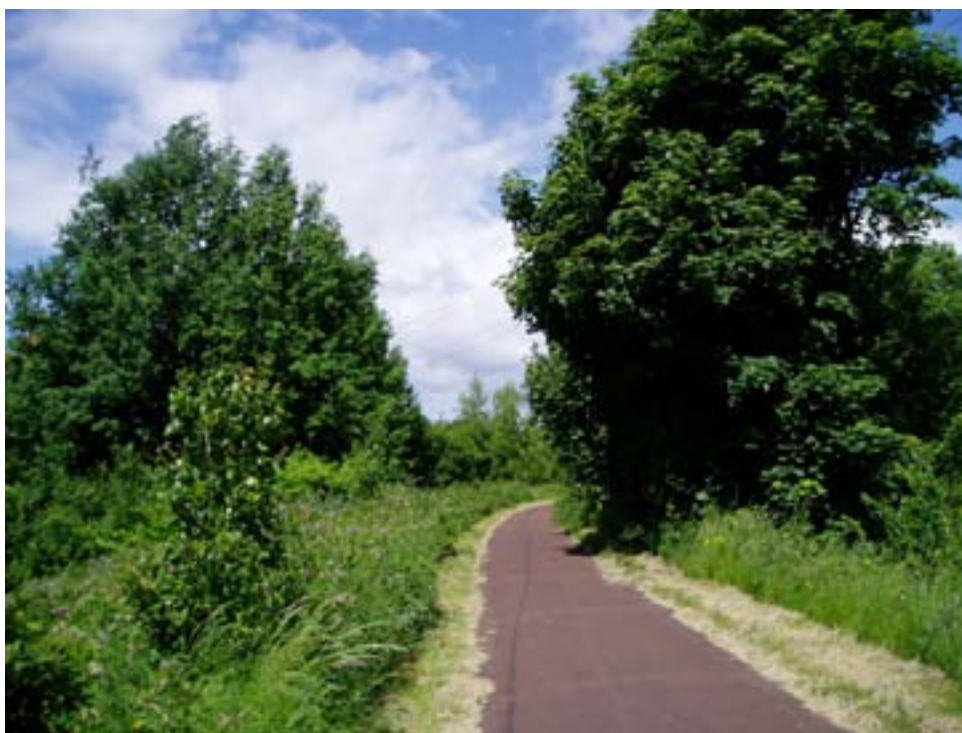
**Figure 19:** Compartment 6f from the south-eastern end, showing aspen suckers colonising open areas on the lower side and sycamore obscuring sight lines round the corner on the upper side.

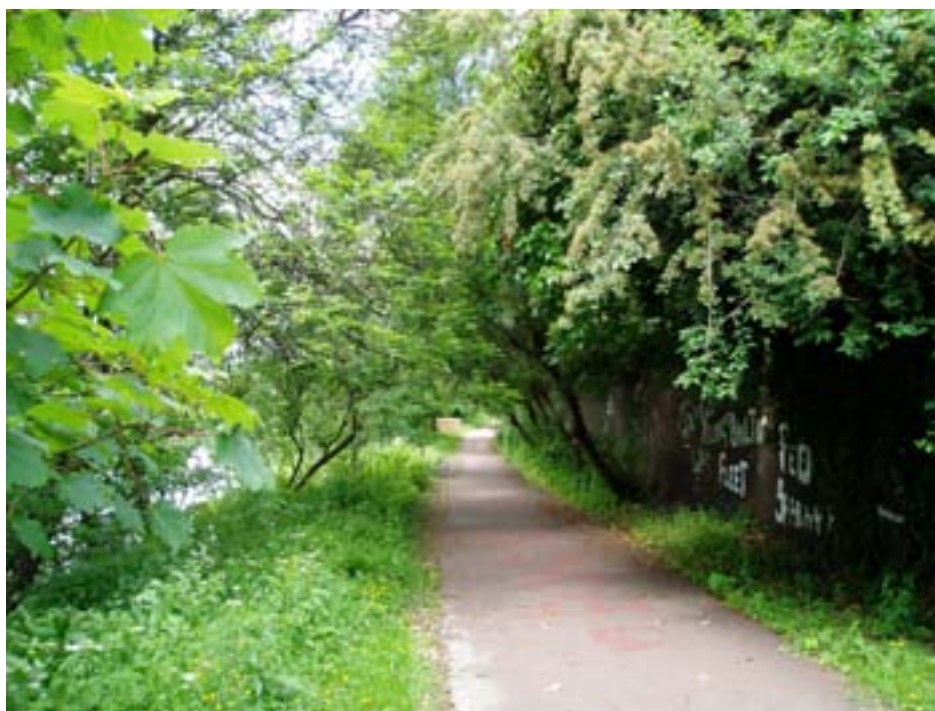
**Figure 25:** Compartment 8a from the south-eastern end, showing trees on the upper side leaning out over the path and the overhanging canopies of hawthorn growing in private ground beyond the fence.

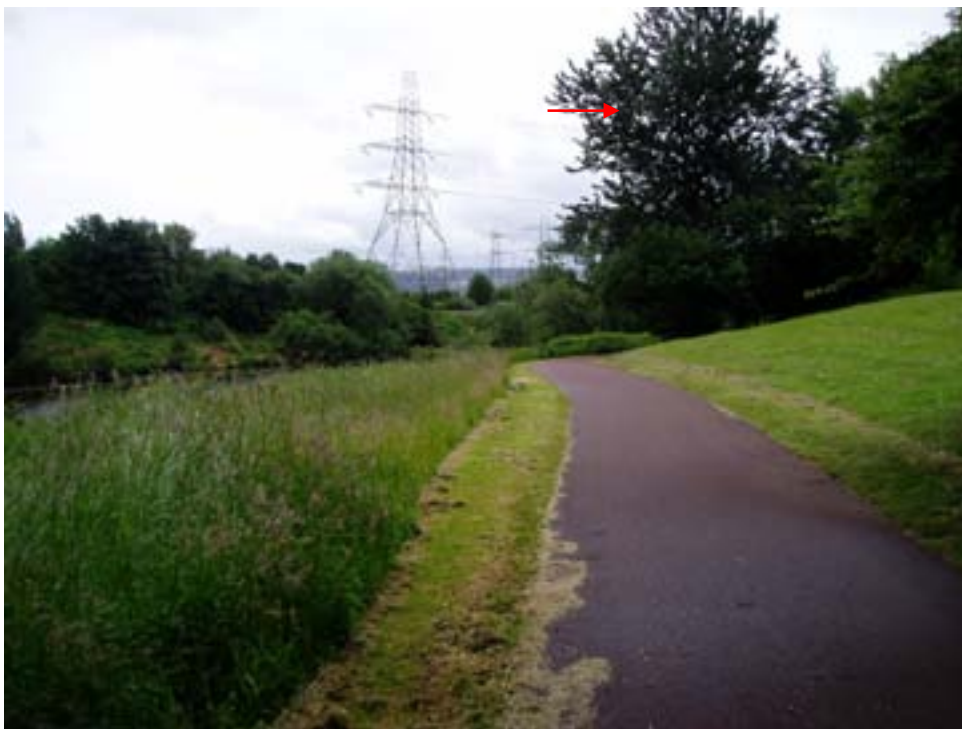
- 3.8.4 Root-damage to the path-surface is widespread wherever large Willow and Poplar, in particular (but not exclusively), are growing close to paths. For cyclists the lifting of the tarred surface may be no more than a cause of discomfort, but there are significant trip-hazards for pedestrians in places, and those trees causing the most severe damage have been included in the hazard-tree schedule. In some cases tree-roots are visible through the cracked surface with some sucker-growth developing in the path, too.
-

**Figure 30:** Compartment 8f from close to the northern end, showing large Balsam Poplar (arrowed), whose roots appear to be lifting the tar, and the extensive open areas on both sides of the path.

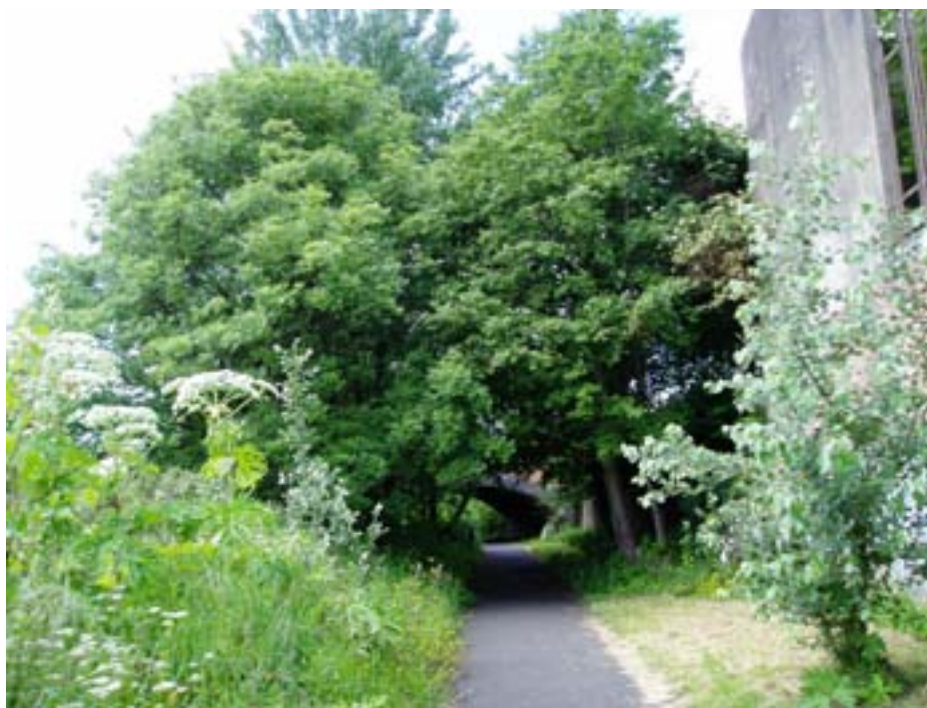
**Figure 33:** Compartment 9c from the eastern end, showing tall Grey Alder on the upper (right-hand) side of the path, whose roots appear to be lifting the tar.

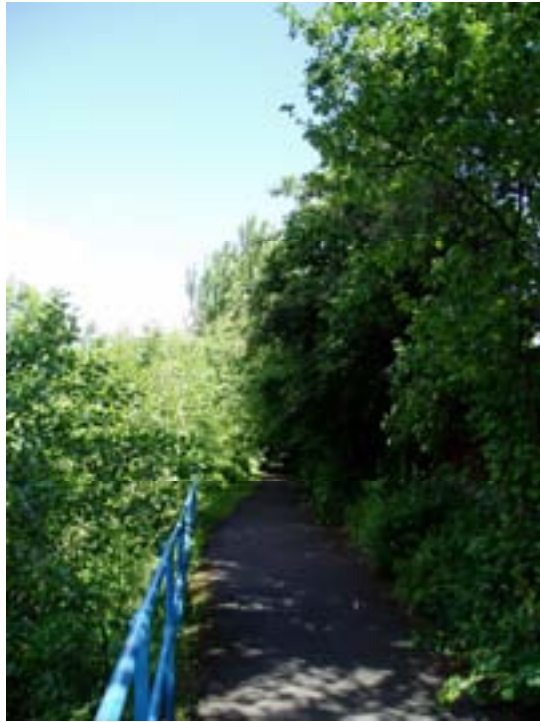
**Figure 39:** Compartment 10f from the southern end, showing dense vegetation encroaching onto the path from the upper side.

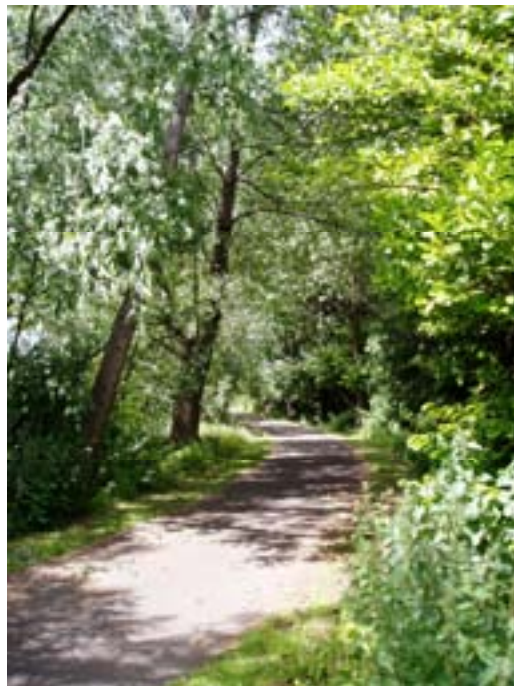
**Figure 42:** Compartment 10i from the south-eastern end, showing tall Willow on the lower side of the path, some of which are beginning to collapse.

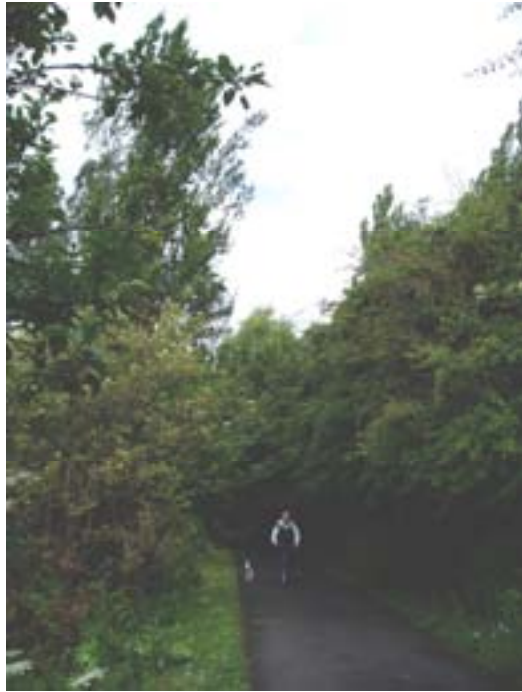
**Figure 43:** Compartment 10j from the south-eastern end, showing dense understorey of Hawthorn / Elder on the upper side heavily overhanging the path

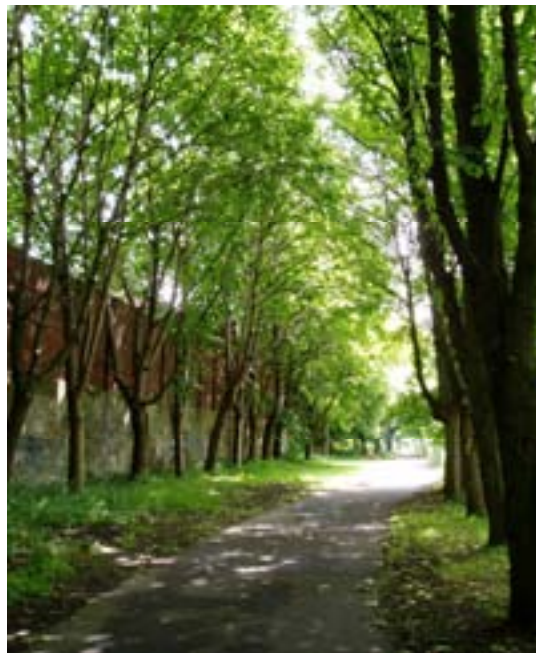
**Figure 46:** Compartment 11a from the central area, looking east, showing the proximity of the Norway Maple on the upper side to the adjacent wall (some branches are resting on the top of the wall).

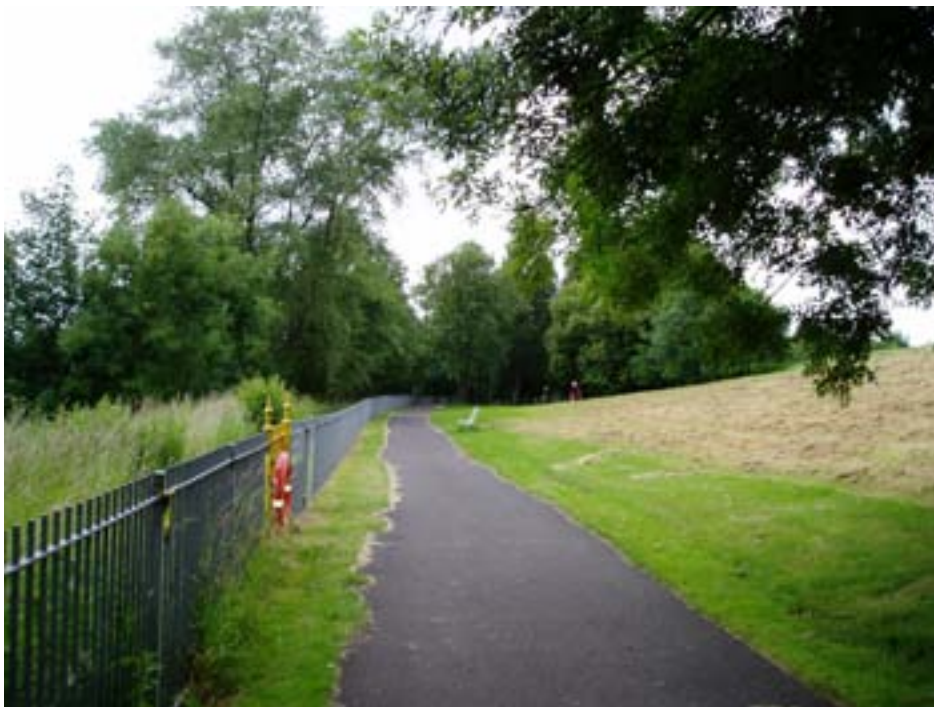
**Figure 48:** Compartment 12 from beneath the Polmadie Bridge. Note the canopy of one of the Ash growing too close to the bridge (right foreground).
