# **SURVEY OF TREES and WOODLAND**

# **THE CLYDE GATEWAY ACCESS PROJECT**

**Prepared for:** **Glasgow & Clyde Valley Green Network Partnership**

2<sup>nd</sup> October 2008

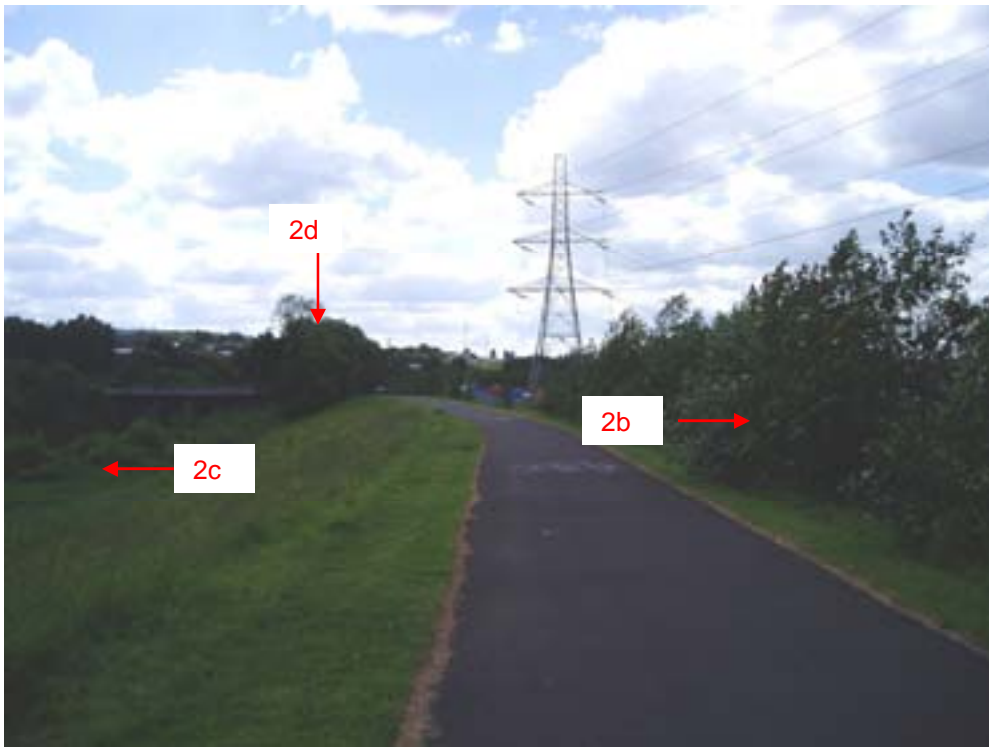
**Figure 3:** Western end of Compartment 2, viewed from the east (various sub-compartments arrowed).

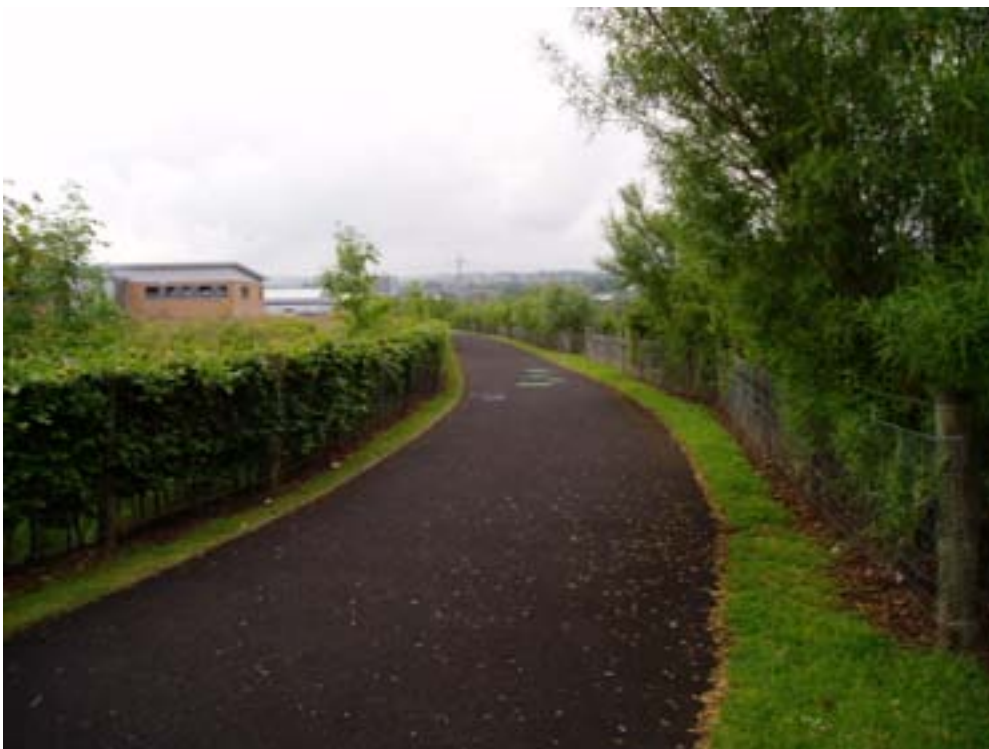
**Figure 4:** Compartment 3a from the north-west (similar in nature to Compartment 2a).

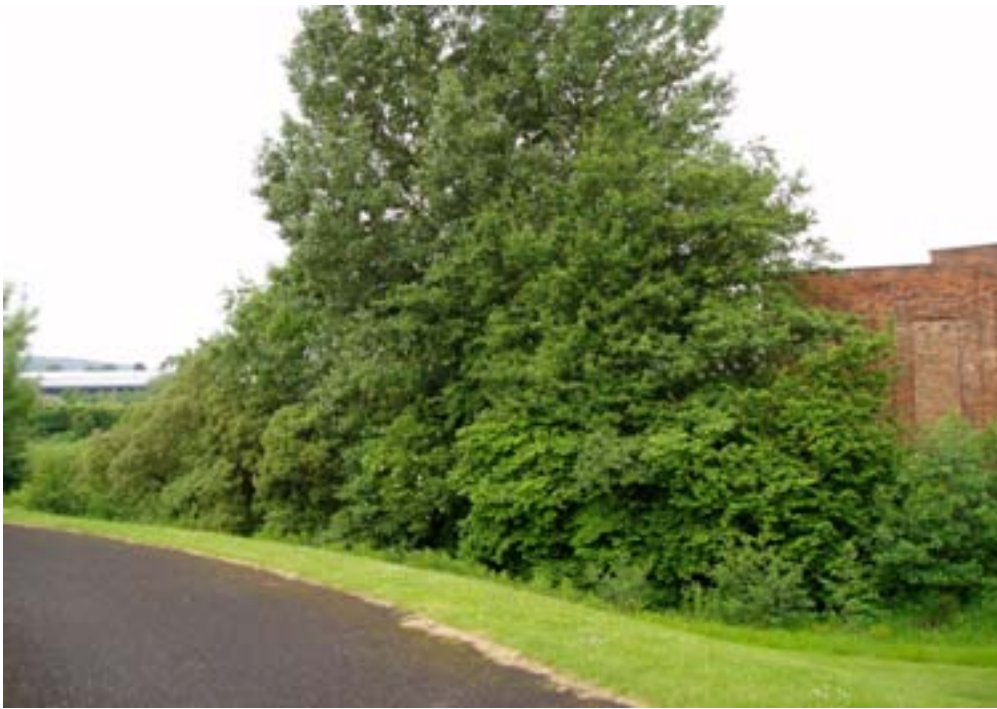
**Figure 5:** Northern end of Compartment 3b, showing dense clump of trees beside derelict building.

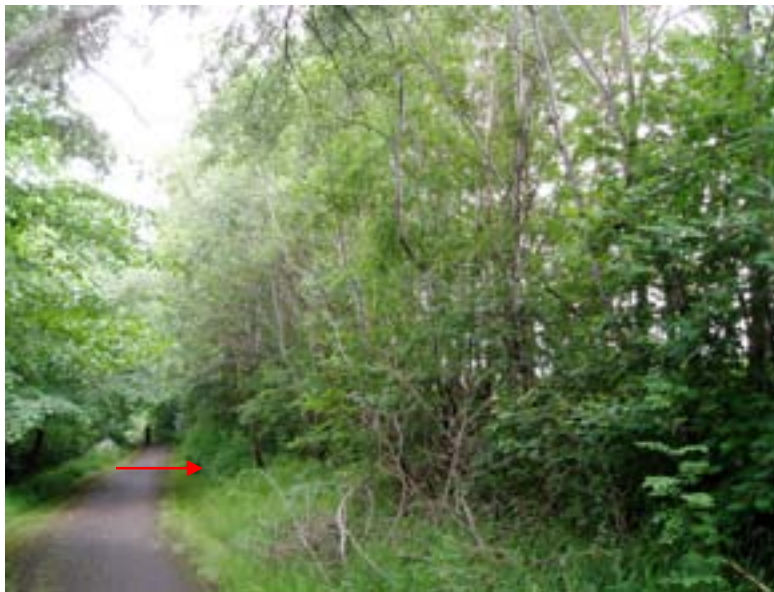
**Figure 8:** Compartment 4c from south-west, showing tall, densely-planted willow, poplar and alder. Arrow indicates dense ash shrub-layer.

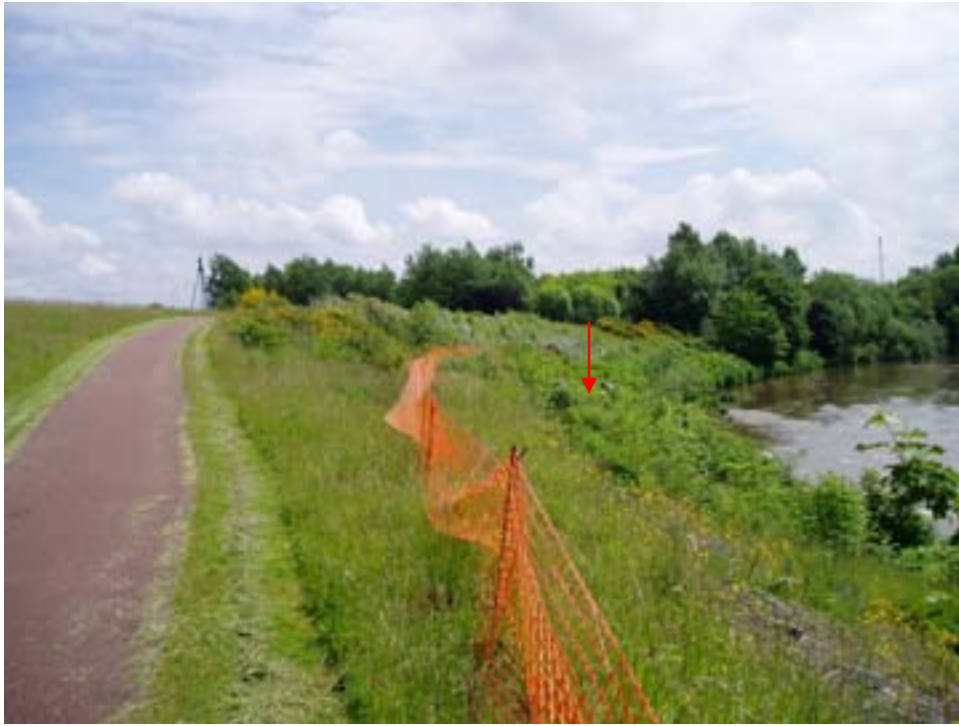
**Figure 11:** Compartment 4g from the west, showing area of dense, young natural regeneration (arrowed).

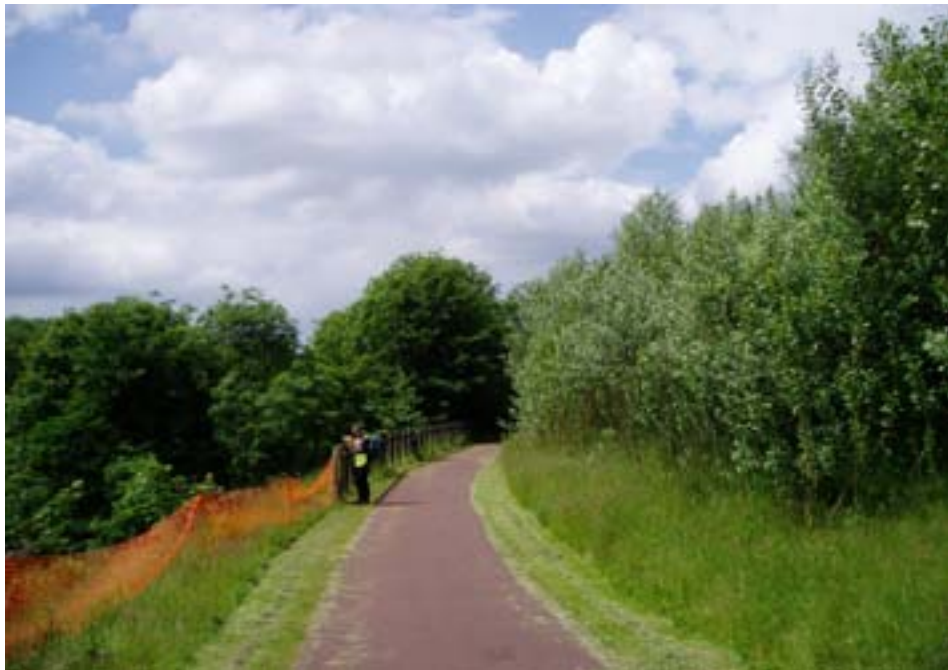
**Figure 12:** Compartment 4h from the boundary with Compartment 4g, showing dense, young trees on north side of path and older trees to the south.

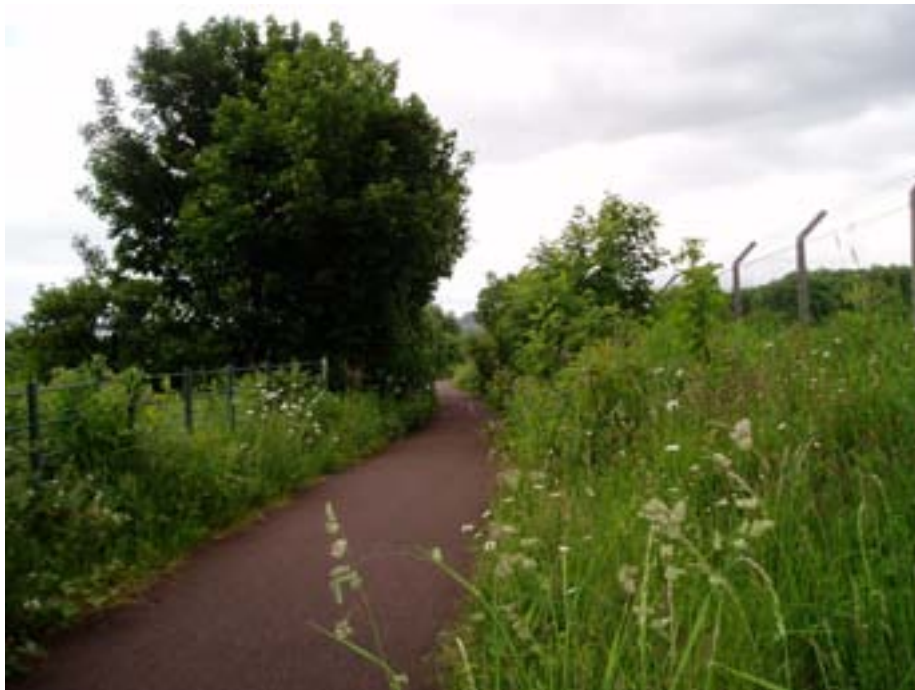
**Figure 16:** Compartment 6c from the north, showing areas of dense vegetation up to the edge of the path interspersed with open areas.

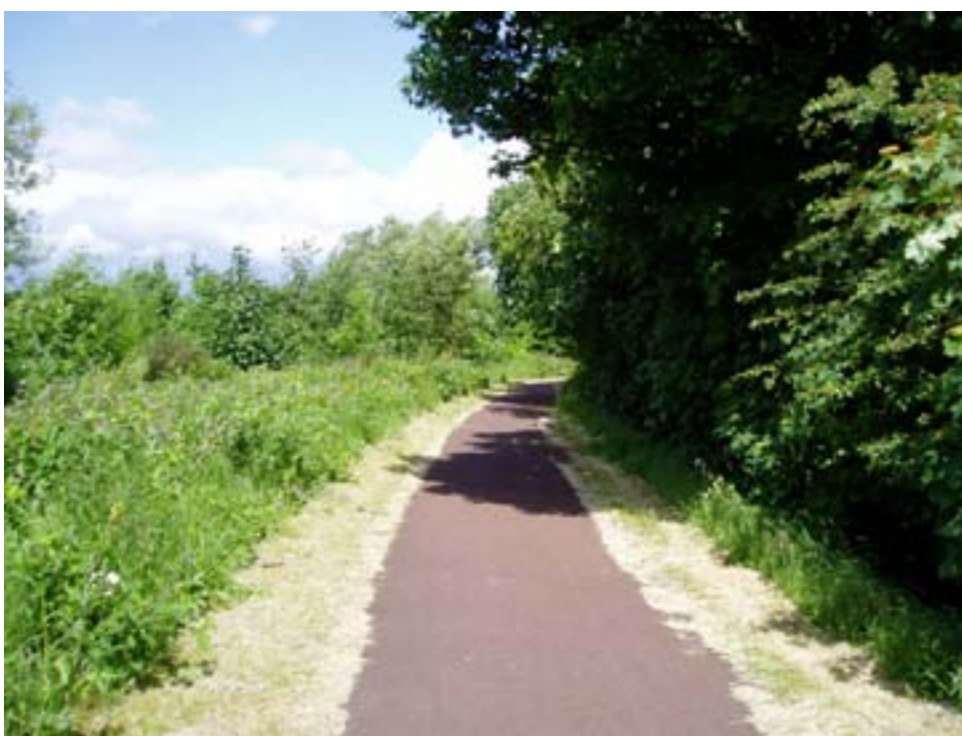
**Figure 20:** Compartment 7a from the southern end, showing young plantations on the lower side and dense belt of young and mature sycamore close to the path on the upper side.

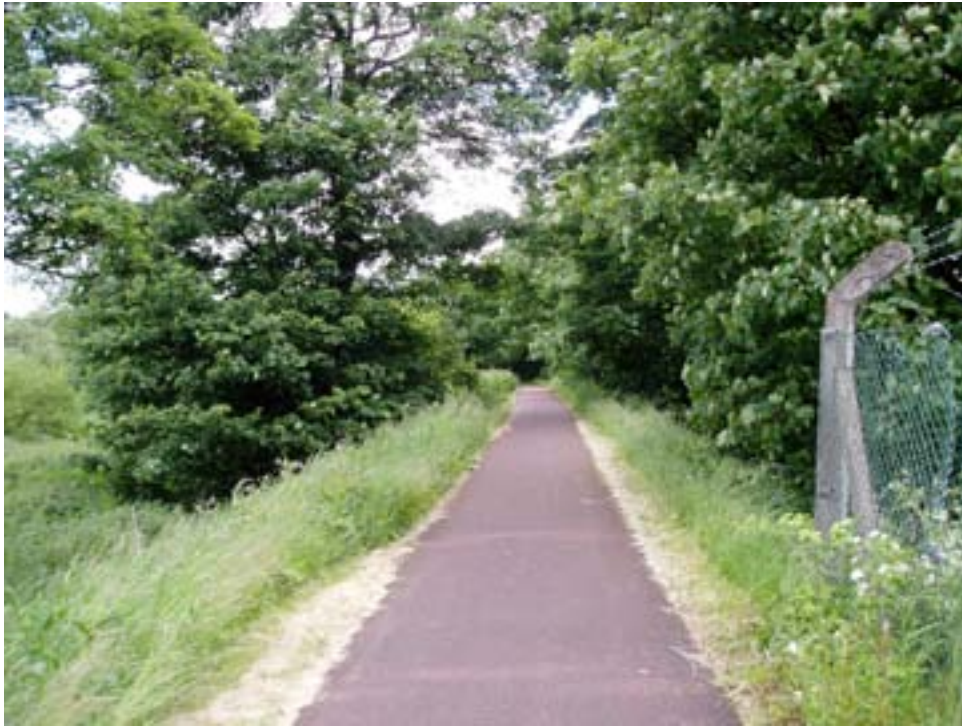
**Figure 21:** Compartment 7b from the south-western end, showing mature sycamore on both sides of the path and extensive open areas on the lower side.

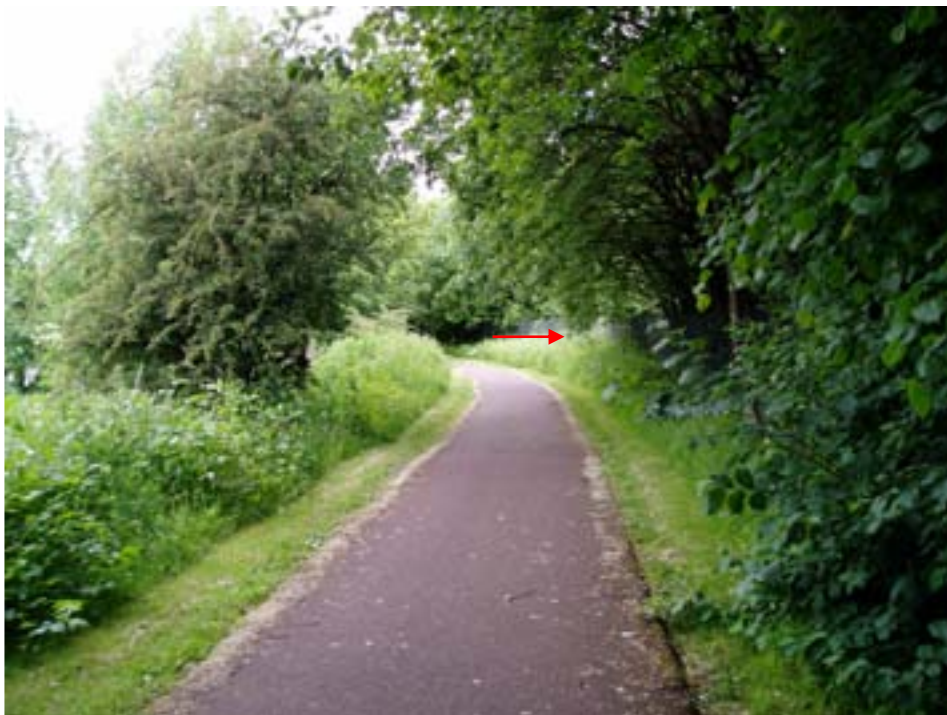
**Figure 22:** Compartment 7c from the south-western end, showing the proximity to the path of the boundary fence on the upper side (arrowed).

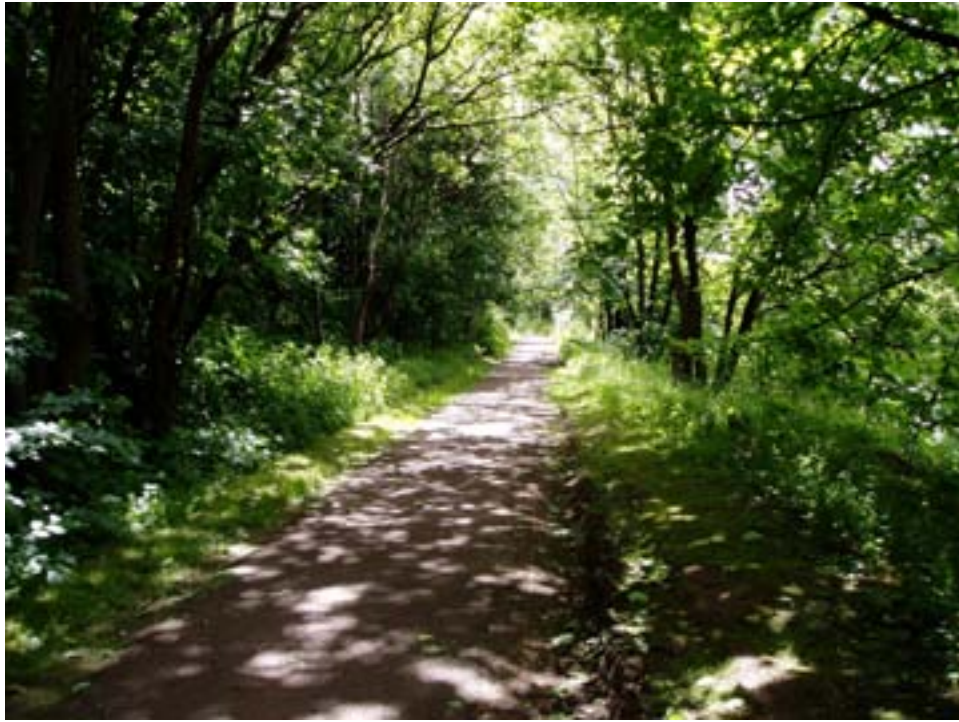
**Figure 23:** Compartment 7d from the north-east, showing dense tree-cover either side of the path.

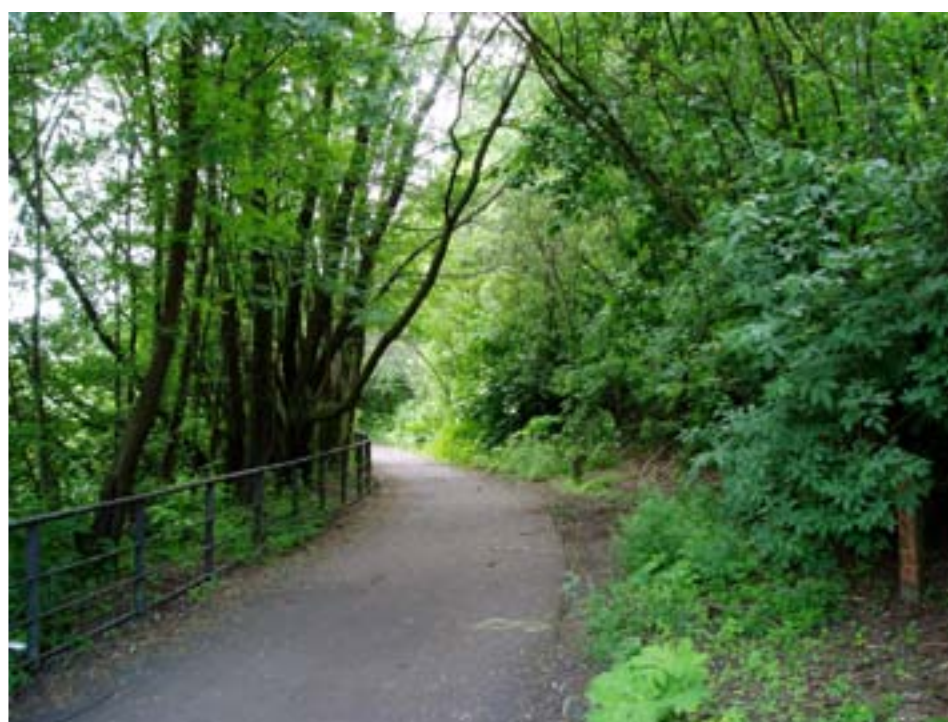
**Figure 26:** Compartment 8b from the eastern end, showing the tall, dense crack willow on the lower side of the path.

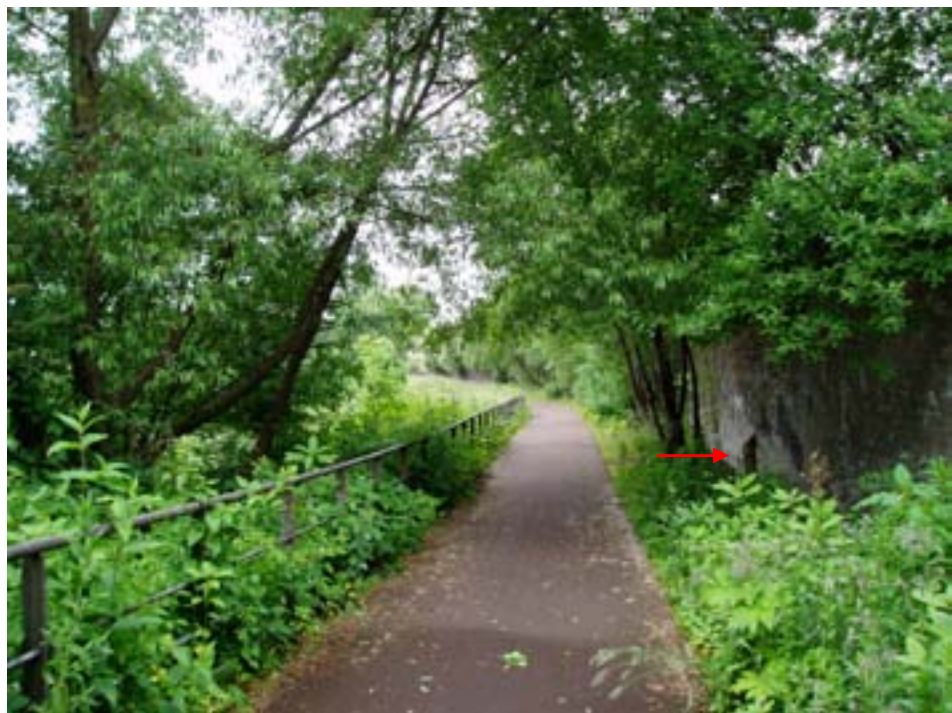
**Figure 28:** Compartment 8d from the northern end, showing remaining willows growing from narrow strip on the upper (right-hand) side of the path and stump of felled tree (arrowed).

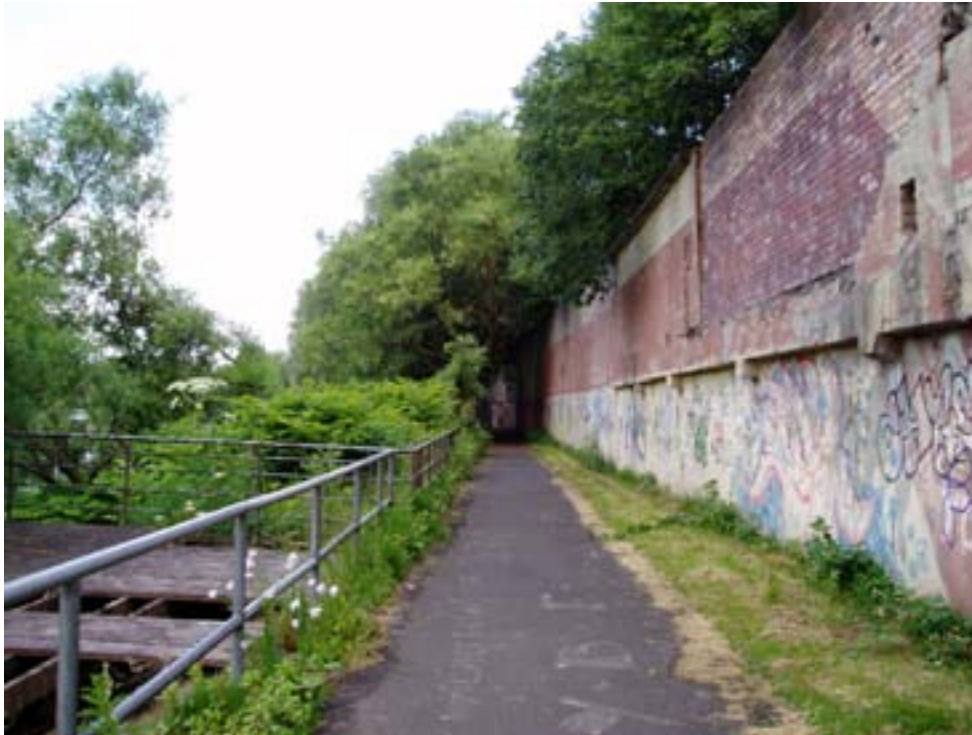
**Figure 31:** Compartment 9a from the eastern end, showing tall Crack Willow and Grey Alder on the lower side of the path.

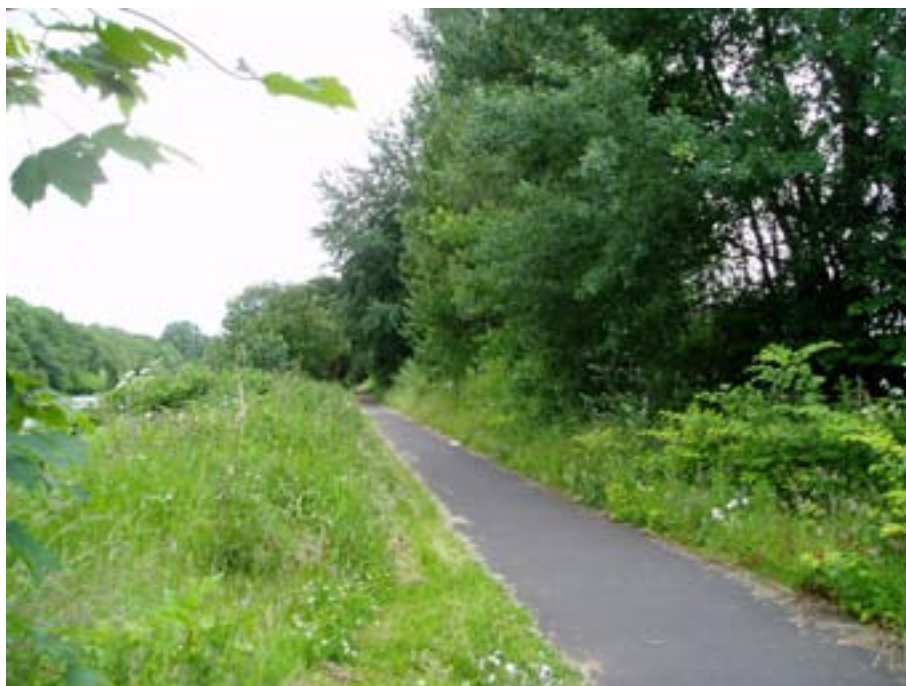
**Figure 34:** Compartment 10a from the north-eastern end, showing the largely open nature of the lower side of the path (with Giant Hogweed in the middle-distance) and dense cover of tall Poplar / Willow on the upper side (with Japanese Knotweed beside the path).

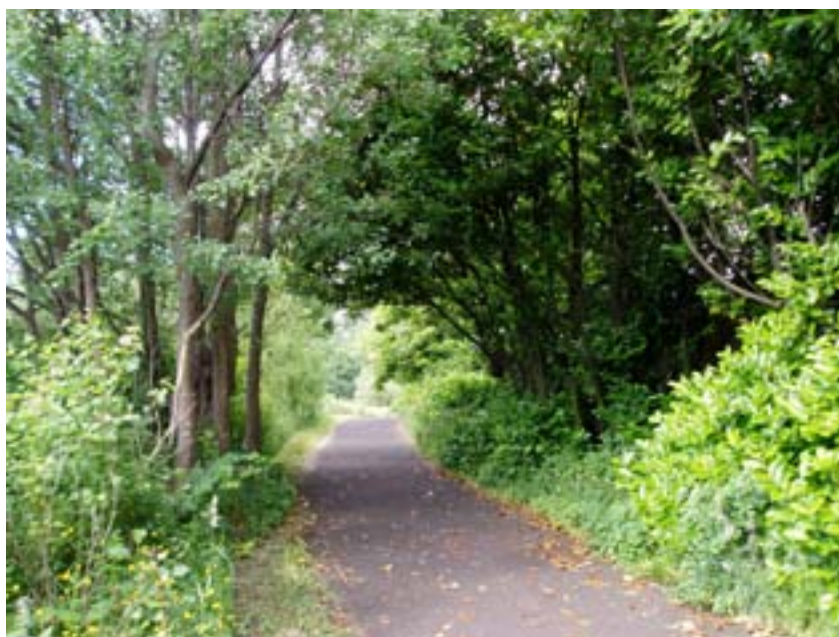
**Figure 35:** Compartment 10b from the north-eastern end, showing dense Cherry Laurel on the upper side of the path and suckering Aspen on the lower side.

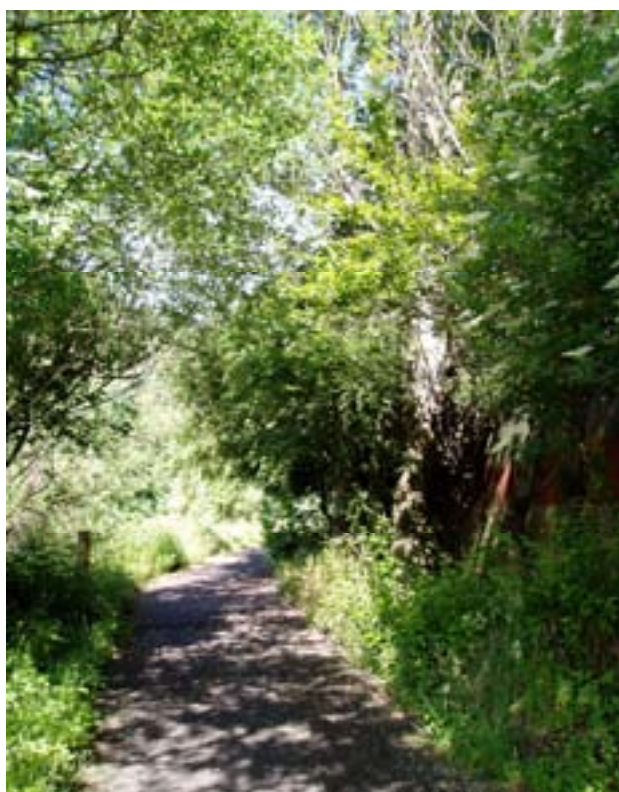
**Figure 36:** Compartment 10c from the south-eastern end, showing trees growing in the very narrow strip of ground between the path and wall on the upper side.

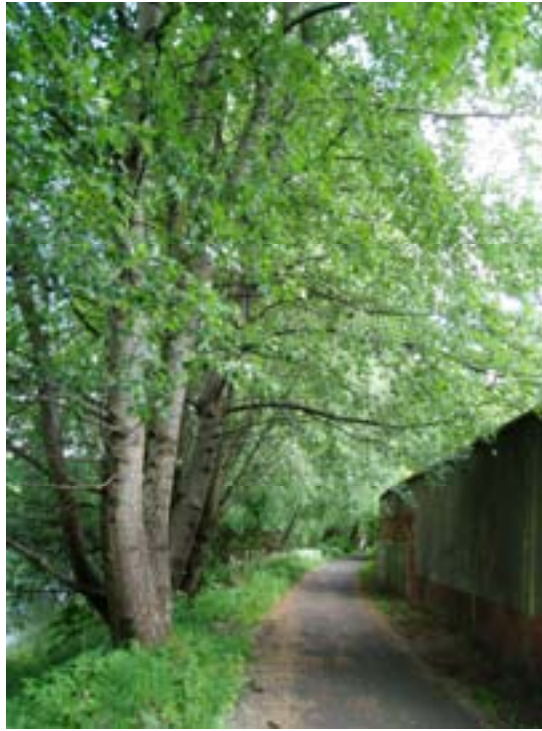
**Figure 37:** Compartment 10d from the south-eastern end, showing lack of trees on the upper side of the path and large Poplar / Willow growing in a narrow strip of ground on the lower side.

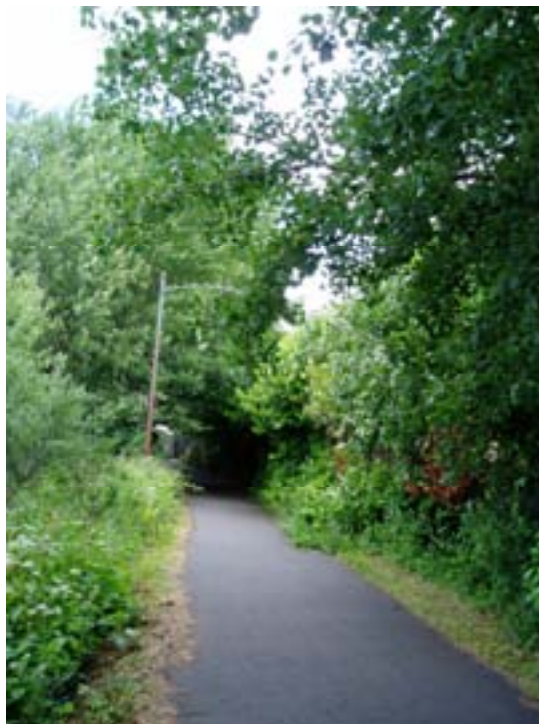
**Figure 40:** Compartment 10g from the south, showing dense Cherry Laurel on the upper side of the path and tall Poplars on the lower.

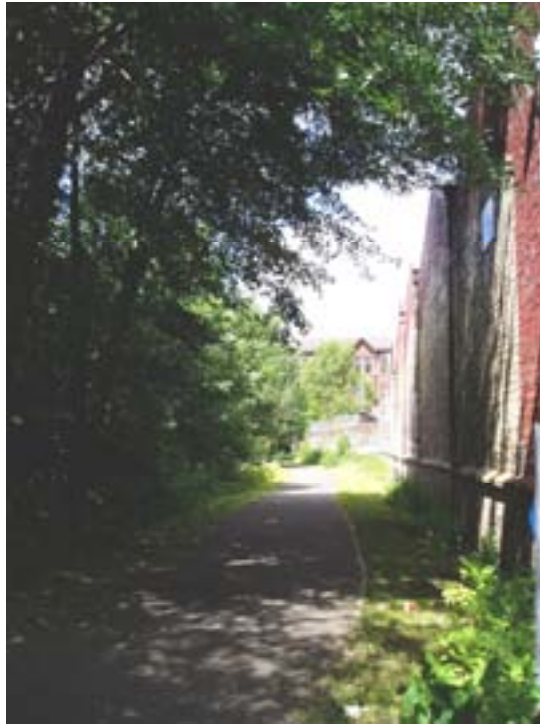
**Figure 41:** Compartment 10h from the southern end, showing tall trees on the lower side of the path.

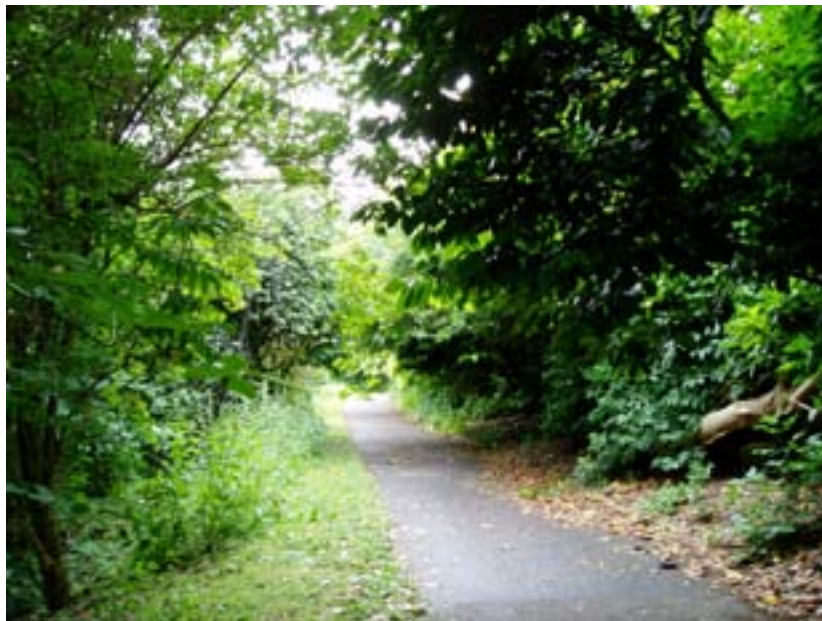
**Figure 44:** Compartment 10k from the eastern end, showing dense Cherry Laurel / Elder on the upper side of the path.

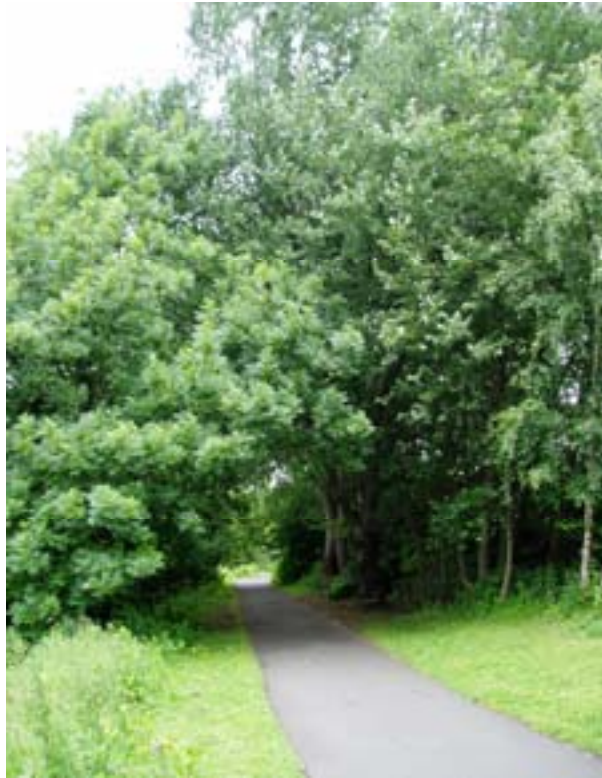
Sub-comp't	Description	Management Issues	Recommendations	Work Priority
10I	<p>The upper side is dominated by Grey Poplar, Crack Willow and Hybrid Black Poplar to circa 20m high with a dense under-storey of Cherry Laurel and Poplar suckers.</p> <p>The lower side has clumps of young to early-mature Crack Willow and Ash up to 20m tall, interspersed with open areas and young natural regeneration of Ash, Elder and Alder.</p>	<p>1. Scattered Giant Hogweed on the river-bank.</p> <p>2. Dense Cherry Laurel and Poplar suckers on the upper side create a sense of enclosure / excessive shading.</p> <p>3. Many Crack Willow, especially on the lower side, are collapsing.</p> <p>4. Grey Poplars at the eastern end are damaging the path.</p> <p>5. Towards the western end, a few trees are growing close to the water's edge.</p> <p>6. On the upper side, close to Rutherglen Bridge, a clump of natural regeneration Ash is too close to the bridge and retaining wall.</p>	<p>1. Eradicate Giant Hogweed.</p> <p>2. Coppice Cherry Laurel and Poplar suckers on the upper side. Re-coppice every 5 years.</p> <p>3. Coppice Crack Willow on both sides of the path. Re-coppice every 5 years.</p> <p>4. Fell the single tree causing the worst path damage and treat the stump with Glyphosate.</p> <p>5. Coppice all trees over 5m tall within 2m of the water's edge. Re-coppice every 7 years.</p> <p>6. Fell all Ash in the fenced triangle beside Rutherglen Bridge and treat the stumps with Glyphosate.</p>	<p>A</p> <p>A</p> <p>A</p> <p>A</p> <p>B</p> <p>A</p>

**Figure 45:** Compartment 10I from the eastern end, showing tall trees on either side of the path.

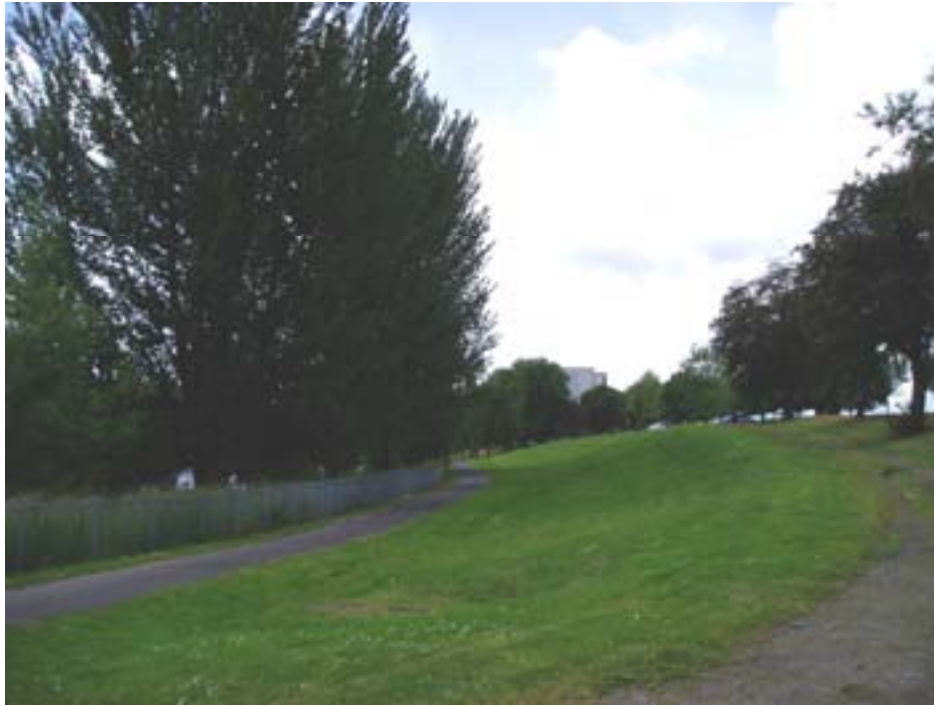
Sub-comp't	Description	Management Issues	Recommendations	Work Priority
11b	<p>The upper side is largely an open area of mown sward. Towards the western end are a few well-spaced, mature specimens of Hawthorn and Ash.</p> <p>The railings on the lower side continue. Trees between the railings and the river consist of young to early-mature Crack Willow, Alder, Hybrid Black Poplar, Ash, Hawthorn and Wych Elm. Towards the western end are a few mature specimens of White Willow, one of which has been extensively pruned / pollarded.</p>	<p>1. Scattered Giant Hogweed on the river-bank.</p> <p>2. A few trees are growing close to the water's edge.</p> <p>3. Large Poplars on the lower side at the eastern end are multi-stemmed with included bark unions, which are likely to fail, and they are also suckering profusely.</p>	<p>1. Eradicate Giant Hogweed.</p> <p>2. Coppice all trees over 5m tall within 2m of the water's edge. Re-coppice every 7 years.</p> <p>3. Fell Poplar suckers and re-cut every 5 years.</p>	<p>A</p> <p>B</p> <p>A</p>

**Figure 47:** Compartment 11b from the eastern end, showing open parkland on the upper side of the path and tall Poplar behind the railings on the lower side.

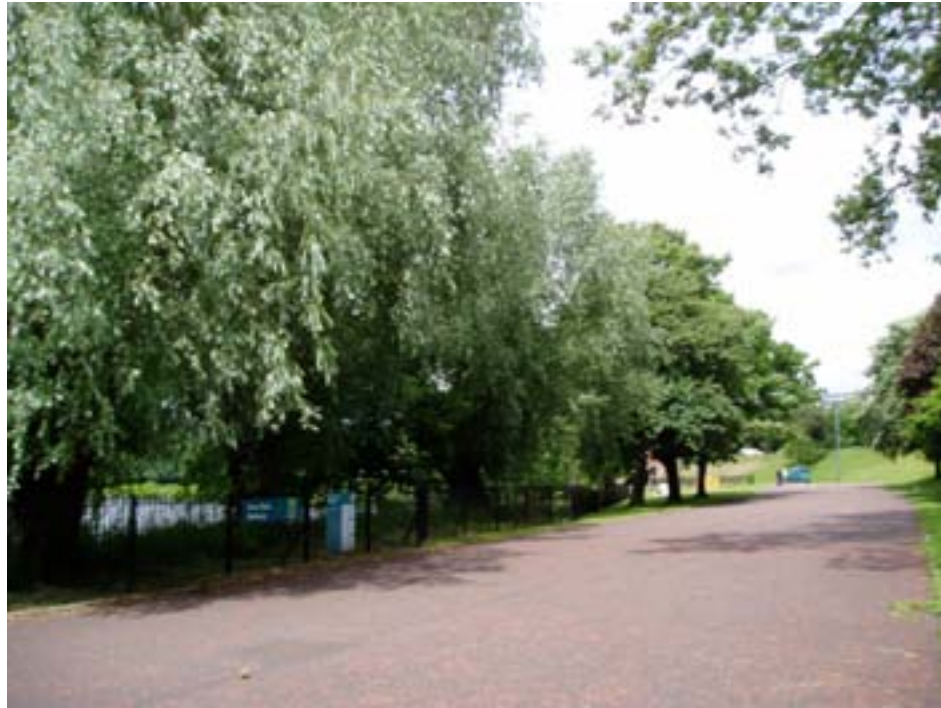
**Figure 49:** Compartment 13 from the southern end, showing one of the large pollarded White Willow on the lower side of the path.

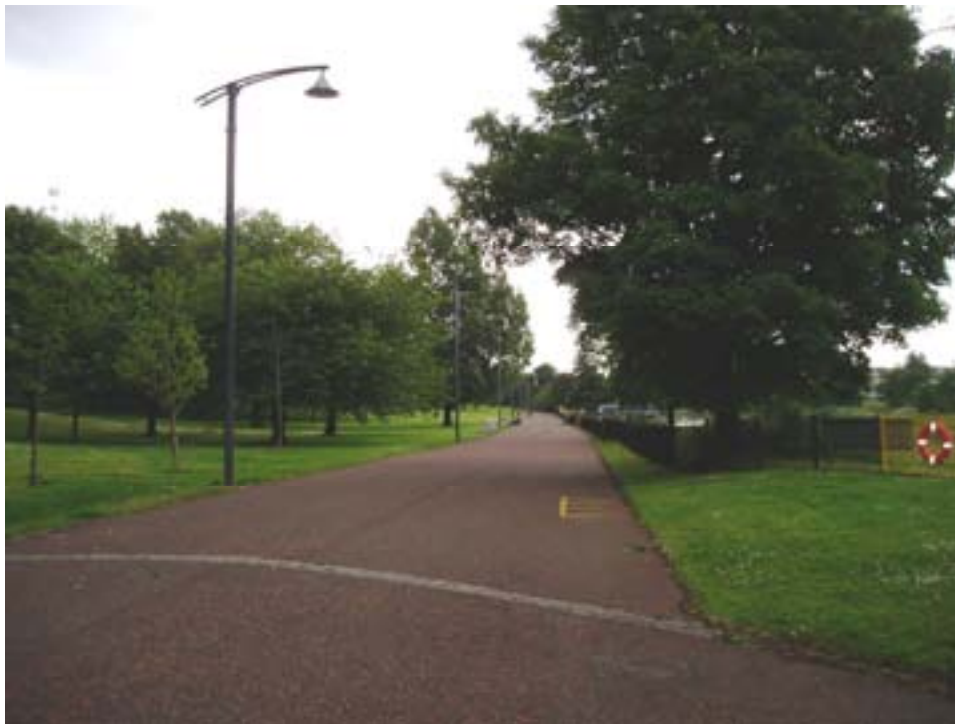
**Figure 50:** Compartment 14a from the north-western end.

14a	<p>Upper side is largely open parkland with a few well-spaced, young to early-mature, specimen trees of many different broadleaf species.</p> <p>On the lower side, the riverbank has very few young to early-mature scattered specimens of Sycamore, Rowan, Alder, Ash and Crack Willow. There are no trees between the path and the railings.</p>	1. Giant Hogweed on the riverbank.	1. Eradicate Giant Hogweed.	A
		2. Long, treeless sections of riverbank.	2. Plant a single row of trees in the treeless section of riverbank at circa 10m centres midway between the railings and the river. Suggested species: Silver Birch, <i>Alnus glutinosa</i> 'Imperialis' and Rowan.	B

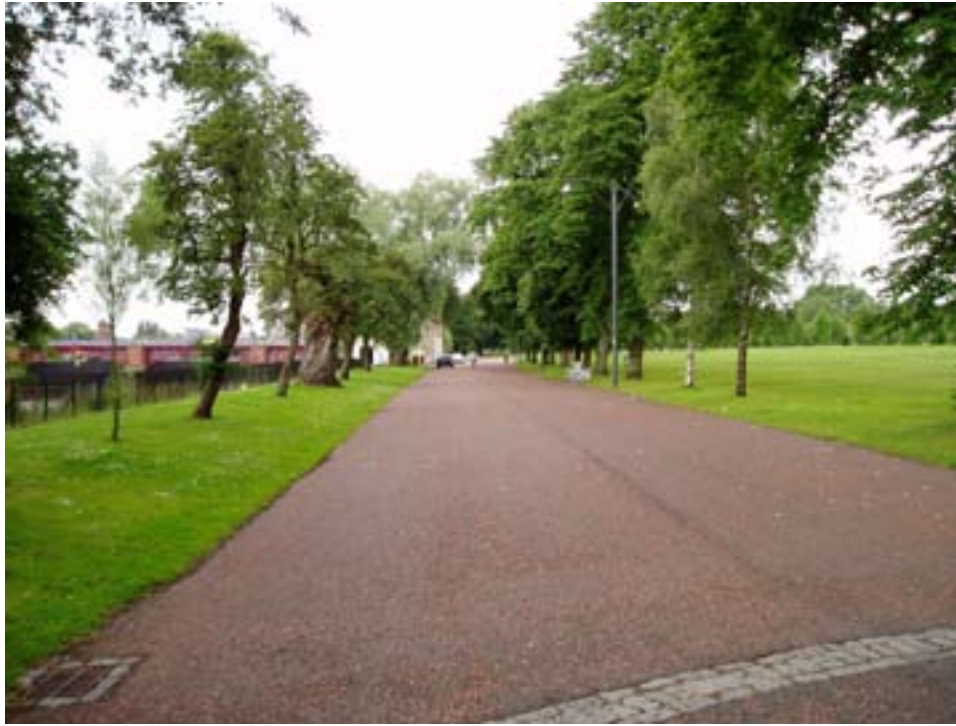
**Figure 51:** Compartment 14b from the south-eastern end.

Sub-comp't	Description	Management Issues	Recommendations	Work Priority
14b	<p>On the upper side, a single row of early-mature Lime and Sycamore to circa 20m tall contains a few young Silver Birch.</p> <p>On the lower side is scattered young natural regeneration of Ash and Hawthorn. Between the path and the railings, a row of mature Hawthorn is interspersed with two large, mature White Willow, one of which has been recently pollarded.</p>	<p>1. Giant Hogweed on the riverbank.</p> <p>2. Gaps in the tree cover on the lower side, both inside and outside the railings.</p>	<p>1. Eradicate Giant Hogweed.</p> <p>2. Fill gaps in the line of Hawthorn with more Hawthorn at circa 5m centres. Plant the river-bank as for compartment 14a.</p>	<p>A</p> <p>B</p>
14c	<p>On the upper side, a single, broken row of newly-planted Oak and Cherry at circa 5m centres at the eastern end gives way to open parkland at the western end.</p> <p>On the lower side, a wide belt of early-mature Whitebeam and Beech to circa 16m tall at circa 5m centres ends just west of the Tidal Weir. Between the Weir and Albert Bridge there are a few widely-spaced, mature Hawthorn inside the railings and a few early-mature to mature White Willow and Sycamore on the river-bank.</p>	<p>1. Small numbers of Giant Hogweed on the river-bank.</p>	<p>1. Eradicate Giant Hogweed.</p>	<p>A</p>
